**DEPARTMENT OF TRANSPORTATION**

Contract #: 04-0120F4Cty: SF/ALA Rte: 80 PM: 13.2/13.9File #: 01.28**WELDING INSPECTION REPORT****Resident Engineer:** Pursell, Gary**Address:** 333 Burma Road**City:** Oakland, CA 94607**Report No:** WIR-000271**Date Inspected:** 09-Jul-2007**Project Name:** SAS Superstructure**OSM Arrival Time:** 630**Prime Contractor:** American Bridge/Fluor Enterprises, a JV**OSM Departure Time:** 1500**Contractor:** American Bridge/Fluor Enterprises, a JV**Location:** Benicia, CA**CWI Name:** Michael Johnson**CWI Present:** Yes No**Inspected CWI report:** Yes No N/A**Rod Oven in Use:** Yes No N/A**Electrode to specification:** Yes No N/A**Weld Procedures Followed:** Yes No N/A**Qualified Welders:** Yes No N/A**Verified Joint Fit-up:** Yes No N/A**Approved Drawings:** Yes No N/A**Approved WPS:** Yes No N/A**Delayed / Cancelled:** Yes No N/A**Bridge No:** 34-0006**Component:** Procedure Qualification Record (PQR) Test**Summary of Items Observed:**

## WELDING INSPECTION REPORT

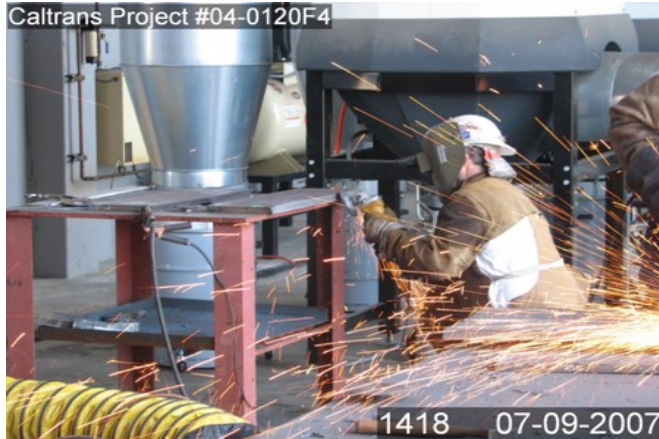
The QA Inspector witnessed the completion of the first attempt of a PQR Test identified as ABF-PQR-026-1. This PQR test is being attempted using the flux-cored arc welding (FCAW) process and a mechanical device that travels on a magnetic track. ABF Representative Mr. Rick Clayborn used a grinder to partially remove weld pass number nine due to fusion problems caused by malfunctioning equipment. Welder Dan Gordon deposited five weld passes on this date. For specific welding parameters recorded during this PQR and digital photographs that support these observations, see Caltrans Welding Witness Report, TL-6032 generated on this date.

The QA Inspector observed Quality Control Representative Mr. Michael Johnson as he performed a visual inspection of the back side of a completed PQR test plate identified as ABF-PQR-026-1 after the removal of temporary fitting aids. Following acceptance by QC and a visual inspection by the QA Inspector, Mr. Clayborn turned the PQR test plate over and began grinding weld reinforcement in preparation for radiographic testing. Grinding of the weld reinforcement was not completed on this date. This test plate will be sent out for radiographic testing sometime in the week to follow.
